SUBJECT: PILOT STUDY SEPTEMBER 2009 EVALUATION
LOWER SILVER CREEK TAILINGS SITE
WORK ASSIGNMENT No. 0-300
TRIP REPORT

Introduction

FIGURE 1
THE PILOT AREA SEPTEMBER 2009,
AFTER ONE GROWING SEASON
LOWER SILVER CREEK TAILING SITE
PARK CITY, UTAH
SEPTEMBER 2009

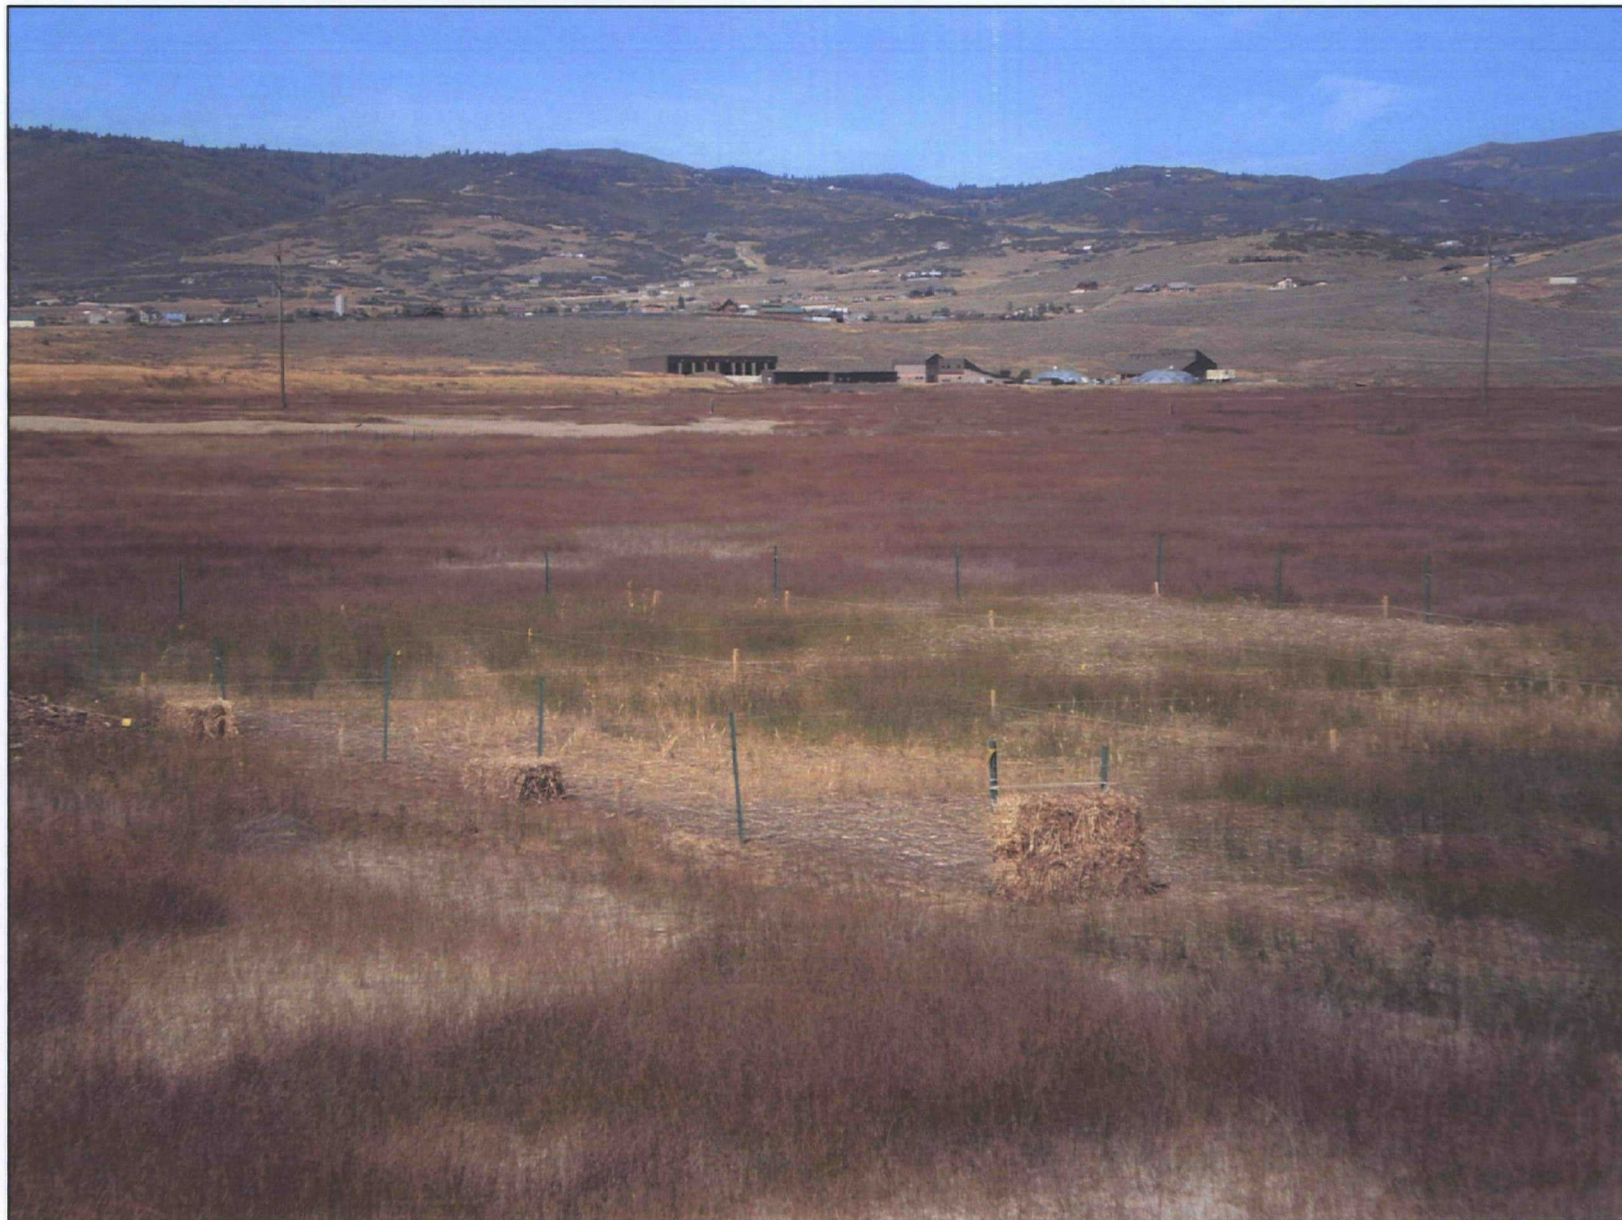
The REAC Task Leader and the WAM arrived at the site on the afternoon of Wednesday, September 16, 2009. The overall condition of the Site was good. Difference in vegetative growth on different plots (soil amendments) were still apparent, but the plants had browned and had already gone dormant both in the plot and in the surrounding areas. The dominant rush "wiregrass" (*Juncus balticus*) still showed some green, but most of the grasses and forbs were already dormant and brown above ground (Figure 1).

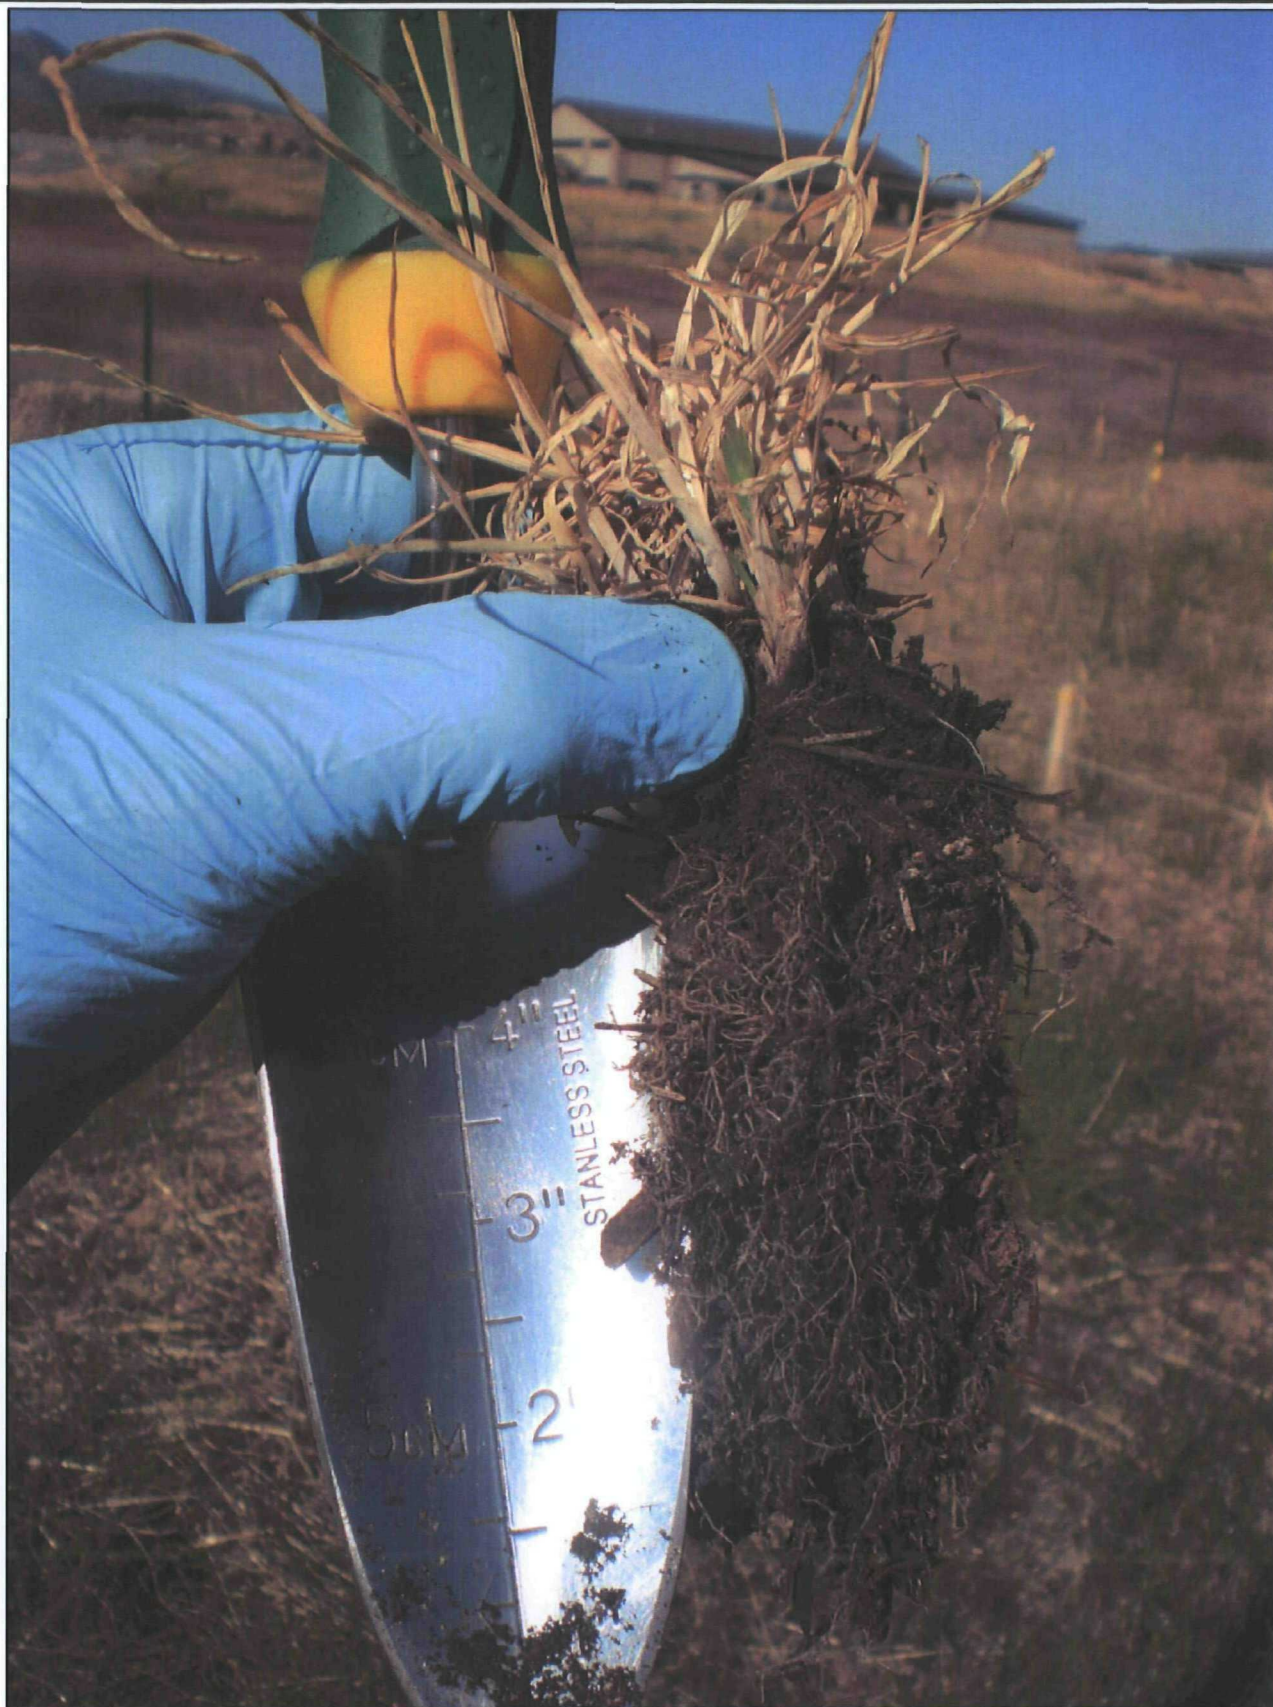
To evaluate and compare the different treatments, it was desired to look at vegetative cover and above ground plant biomass at the end of this first growing season. Unfortunately, much of the germinated seed mixture had already died back, and some of the above ground plant material was already decayed and lost. However, it was observed that many of the grasses were dormant and demonstrated healthy root systems (Figure 2). These perennials will regrow during the 2010 growing season.

FIGURE 2
DORMANT GRASS PLANT WITH,
HEALTHY ROOT SYSTEM
LOWER SILVER CREEK TAILING SITE
PARK CITY, UTAH
SEPTEMBER 2009
